Long-Term Surveillance and Maintenance Plan for the Monticello NPL Sites

U.S. Department
of Energy

Office of Legacy Management

Work Performed by S.M. Stoller Corporation under DOE Contract No. DE-AC01-02GJ79491
for the U.S. Department of Energy Office of Legacy Management, Grand Junction, Colorado

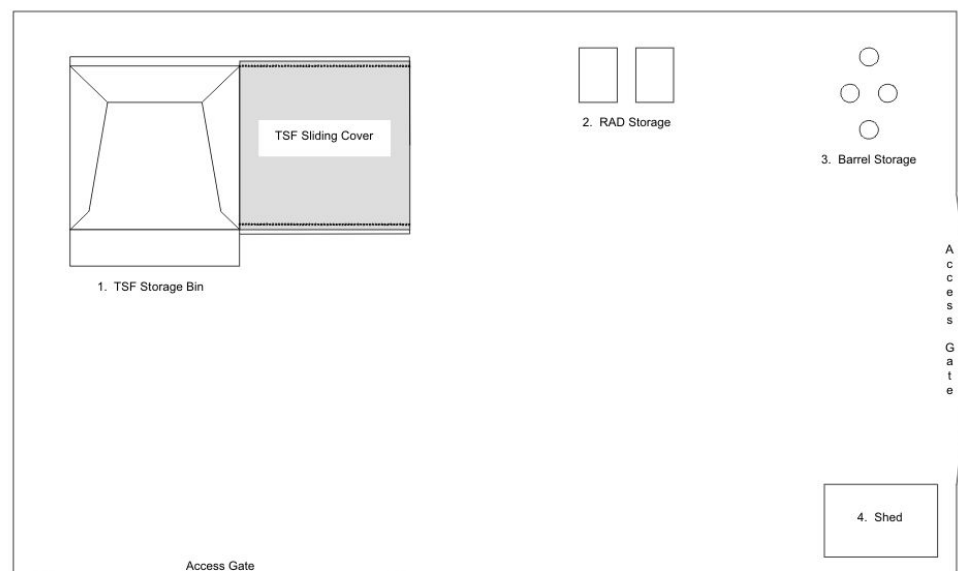
Figure 3-9. Radiological Survey Form

^aNet count rate = gross count rate minus background count rate. ^bSee Table 2-2 of Site Radiological Control Manual (STO 3). ^cC = conditional release; UC = unconditional release.

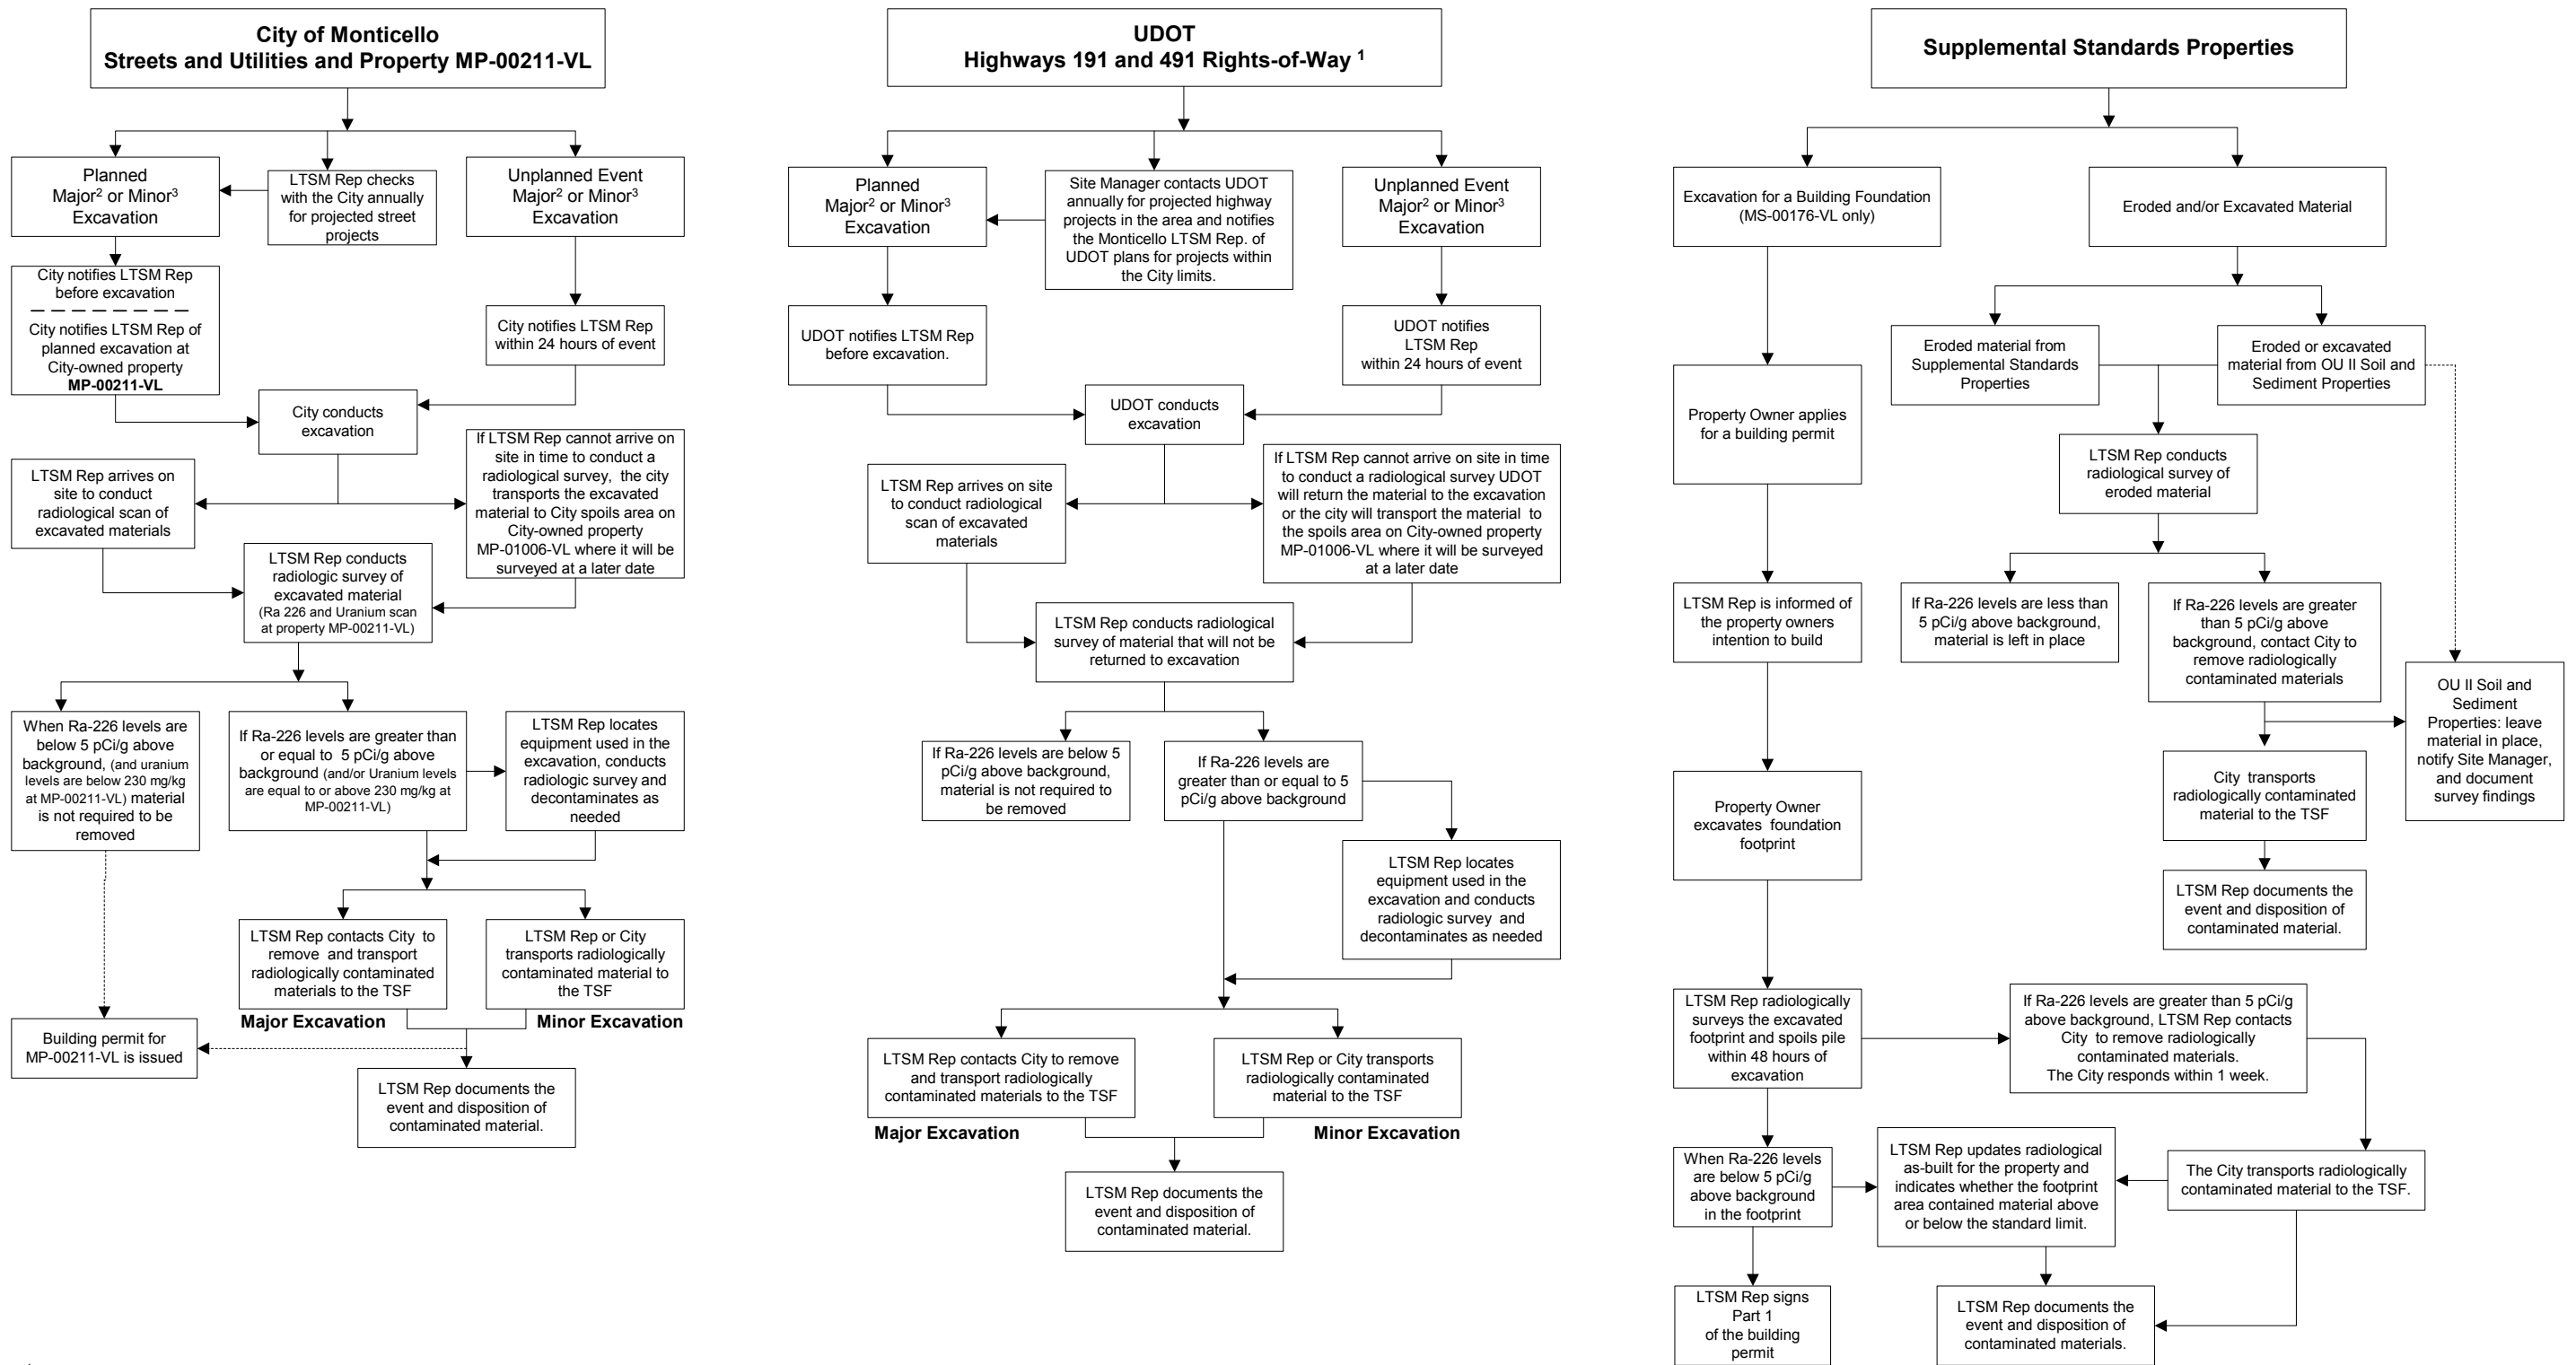
¹ Typically the City of Monticello will complete repairs to Highways 191 and 491 within the city limits with oversight by UDOT.

² Major excavation - Excavations that require the use of heavy motorized equipment to excavate soil beneath or adjacent to city streets, utilities, Highways 191 or 491 rights-of-way. For example, replacing or repairing buried utility lines, installing a culvert, replacing road base beneath a paved surface or replacing fill material in an embankment would constitute a major excavation.

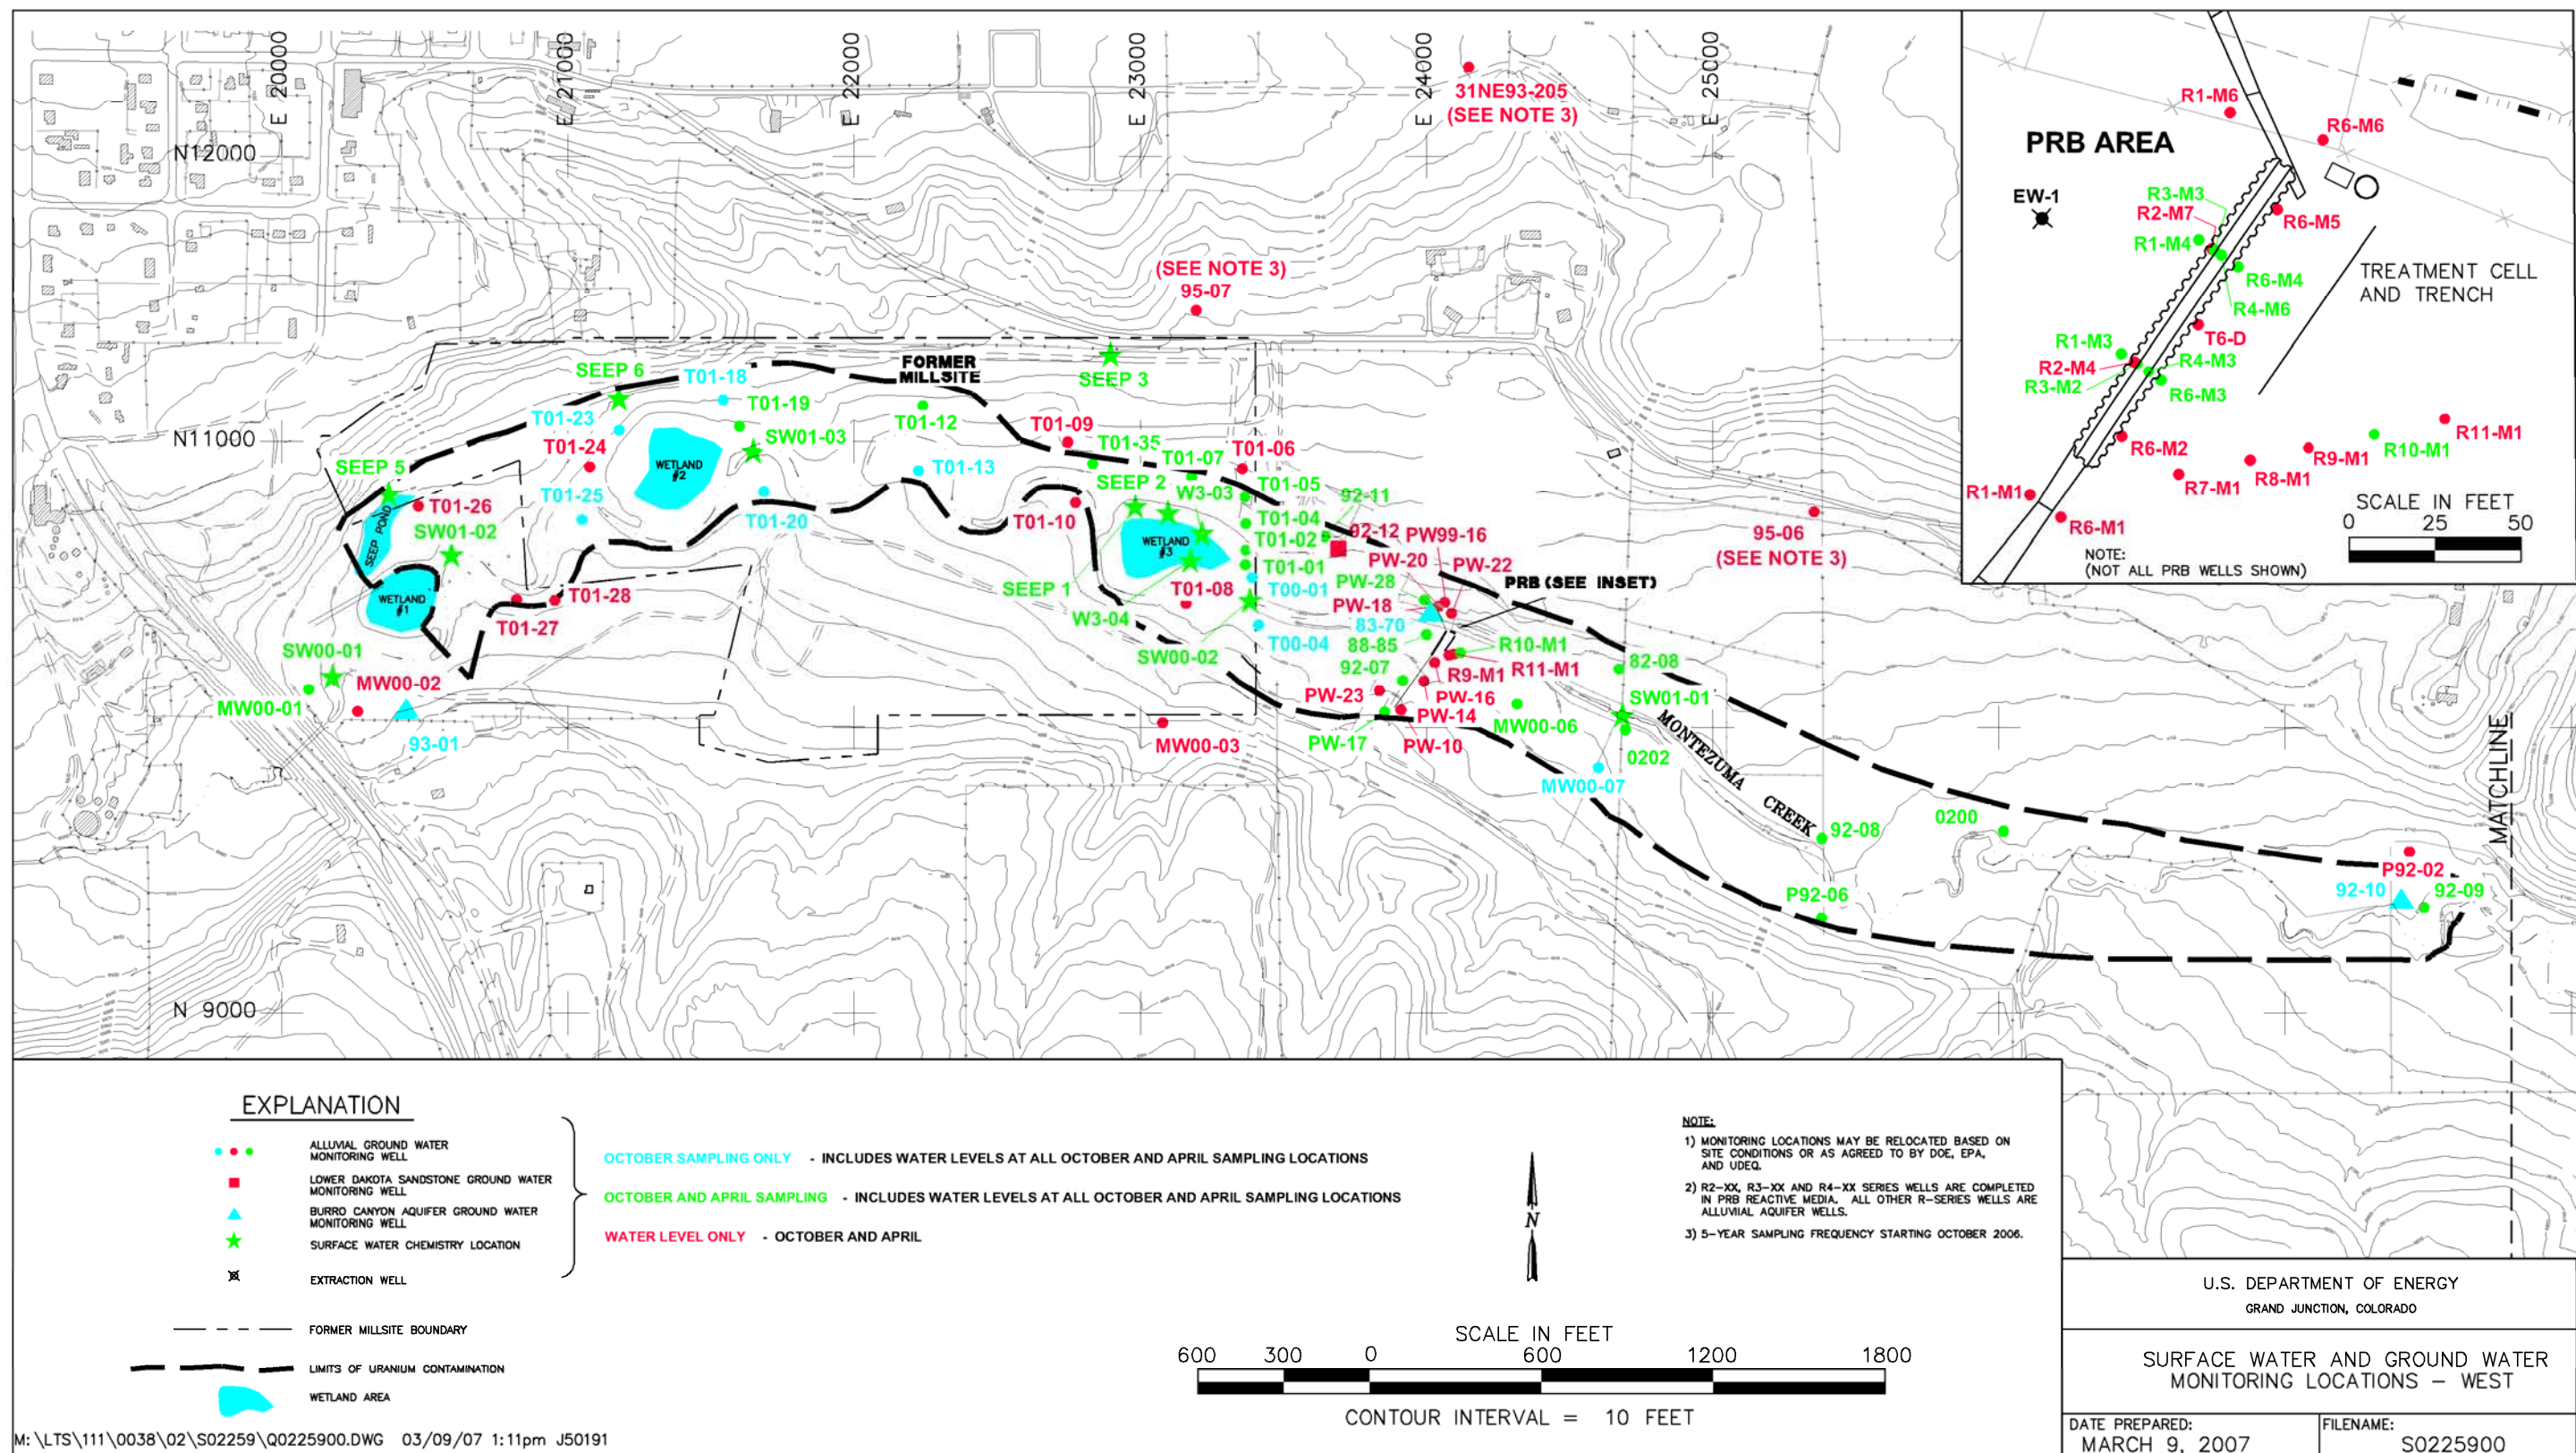
The established network of ground water monitoring wells and surface water locations are visited in October and April of each year, at which time water samples are collected, the water level in each well is measured, and surface water flow at designated locations is measured. Figure 5–2 and Figure 5–3 depict the scope of the surface and ground water monitoring since post-OU III ROD monitoring began in October 2004. Monitoring in October is slightly more comprehensive in scope than in April. In April, several alluvial wells located beyond the extent of contamination, and numerous bedrock wells, are not sampled. April and October sampling events were selected to characterize site conditions during seasonal periods of high and low flow, respectively, in the hydrologic system.
